STERLING

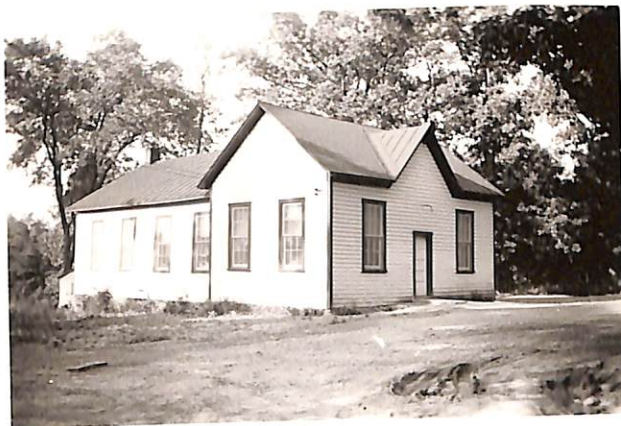
A one story, detached, frame building with metal roof, on stone foundation, containing two rooms, heated by stoves, the flues to which are of standard construction, lighted by electricity. This building is approximately 26' X 72' and is in poor condition, the walls appear to have buckled and the floor has dropped down slightly.
